Manhole Inspection Summary

Manhole # S13AA2015MH

Location Address: **2310 SULGRAVE AVE** Cross Street: **RIDGEDALE RD**

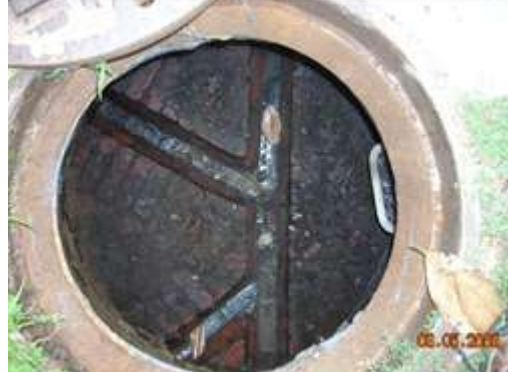
Top View

Evidence of surcharge - Bench debris.
Channel debris.

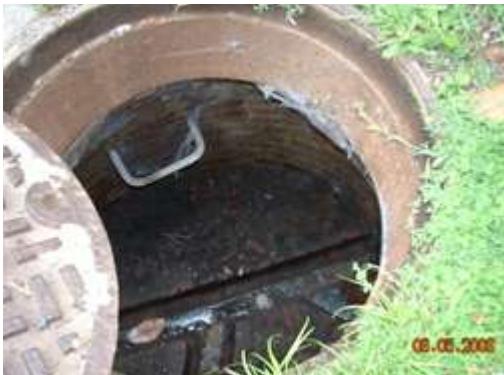
Defect

Frame leaks. Corbel deterioration and infiltration. Barrel infiltration - other side.

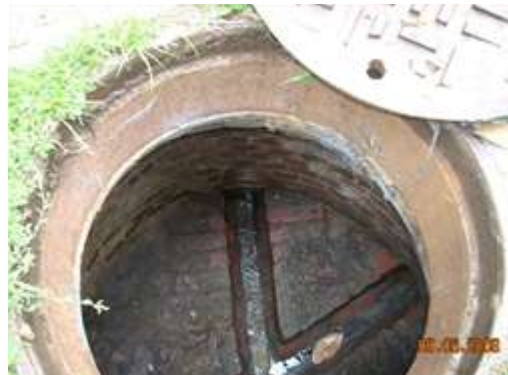
Defect

Frame leaks. Corbel deterioration and infiltration. Barrel infiltration.

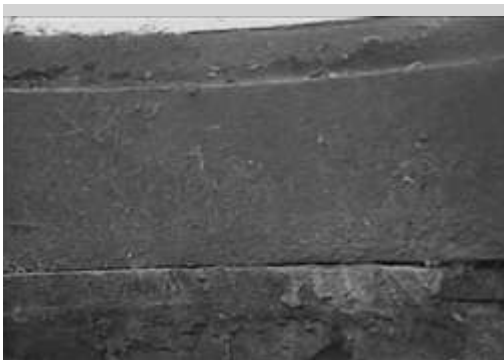
Defect

Frame leaks. Corbel infiltration.

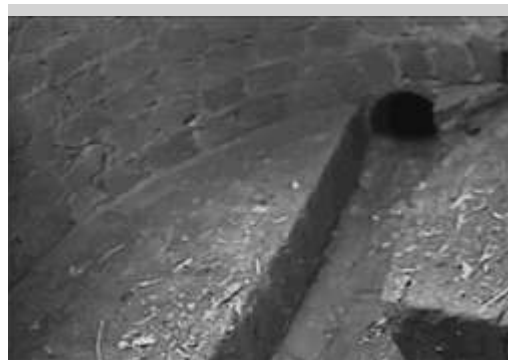
Defect

Barrel deterioration and infiltration.

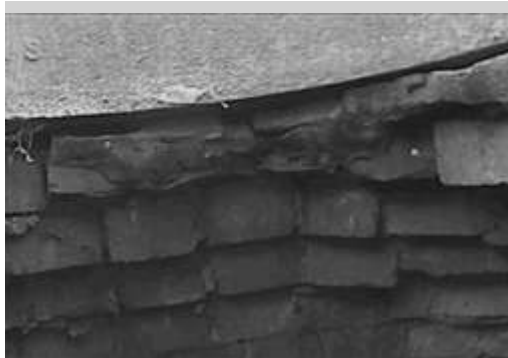
Defect

Frame leaks. Corbel deterioration and infiltration.

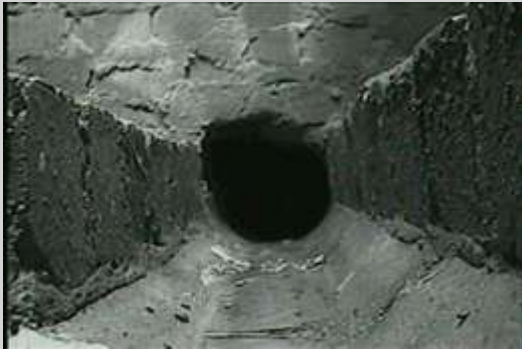
6 in. Circular Gravity Sewer Pipe Out @ 12 O'Clock

Infiltration: **Evidence** Pipe Seal Cond: **Broken**

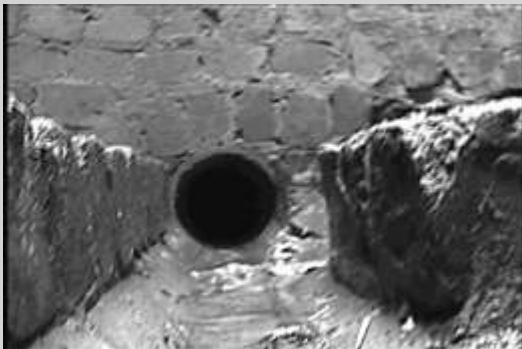
6 in. Circular Gravity Sewer Pipe In @ 6 O'Clock

Channel deterioration.

Infiltration: **Evidence** Pipe Seal Cond: **Unknown**

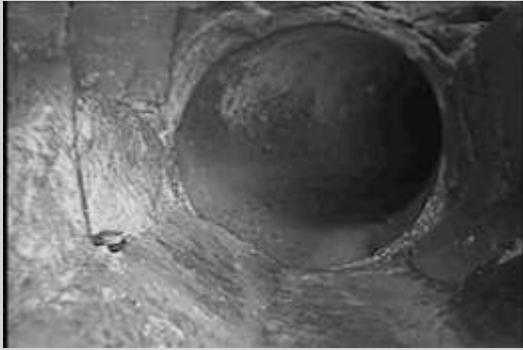
Pipe In @ 7 O'Clock

Infiltration: **Evidence** Pipe Seal Cond: **Cracked**

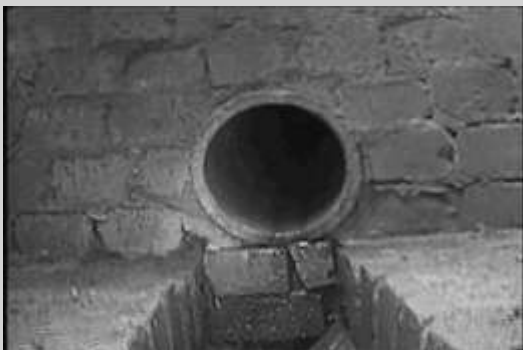
Pipe In @ 11 O'Clock

Infiltration: **Evidence** Pipe Seal Cond: **Unknown**
